Appendix B

Images from an 'all walls out' woolaway refurbishment. This is a comprehensive renewal of the building and home.

b: "Walls Out" Refurbishment
of PRC Woolaway houses
Illustrations of the construction method

Job No: 080231 Photosheet No: Page 1 of 3

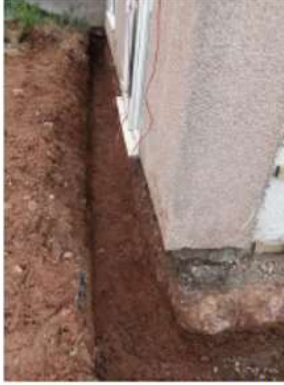
P1 – Excavation for foundation extension

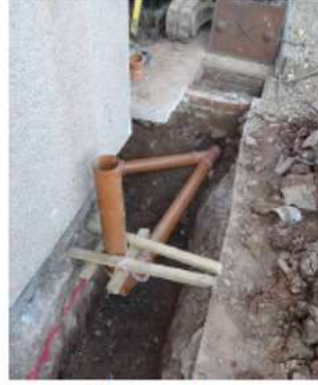
P2 – New drainage

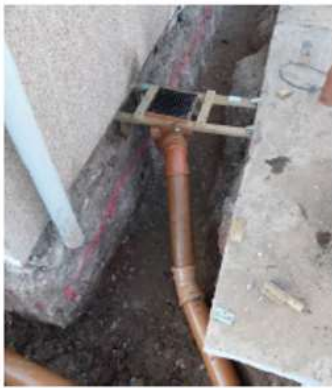
P3 – New drainage

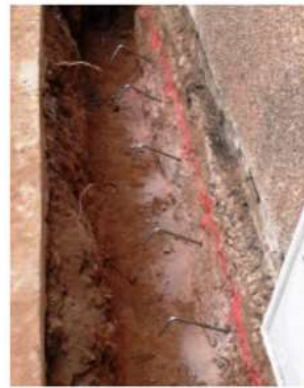
P4 – Dowel bars into existing foundations

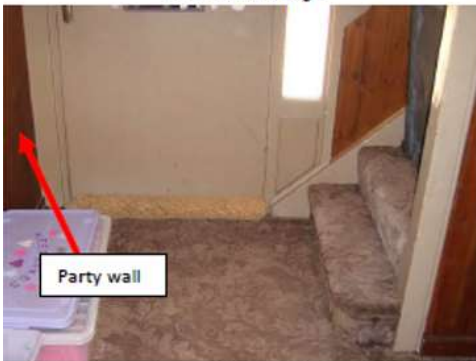
P5 – Staircase running parallel to the front wall (see also P9).

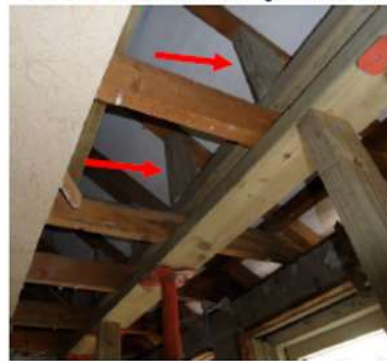
P6 – First floor propping with vertical support to roof rafter

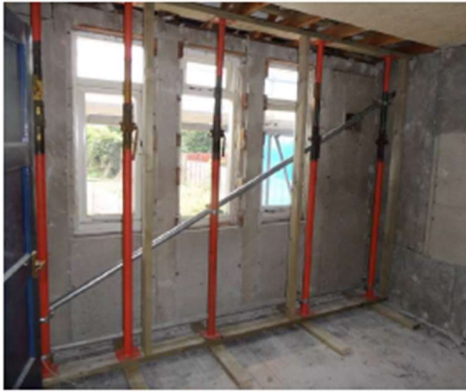
P7 – Ground floor propping (prior to erection of security screening)

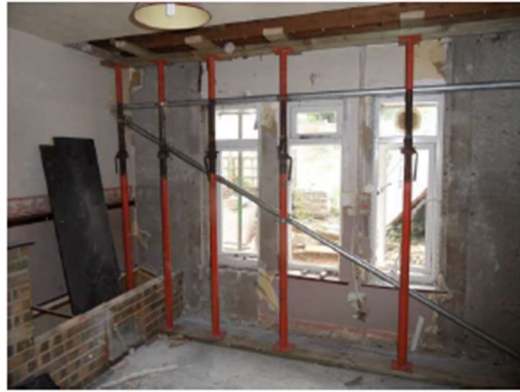
P8 – Ground floor propping (prior to erection of security screening)

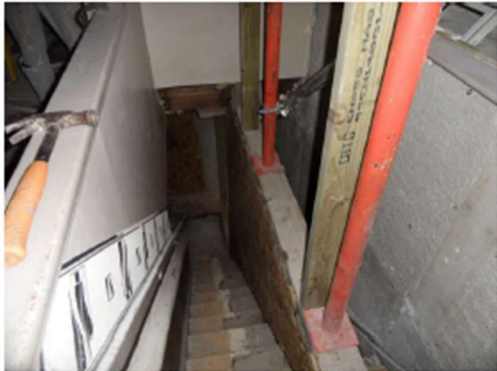
P9 – Propping on stairs (security screen at ground floor, first floor to be erected)

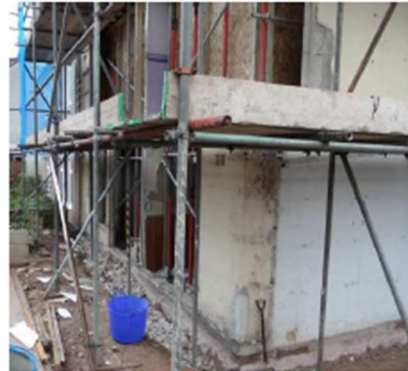
P10 – Demolition

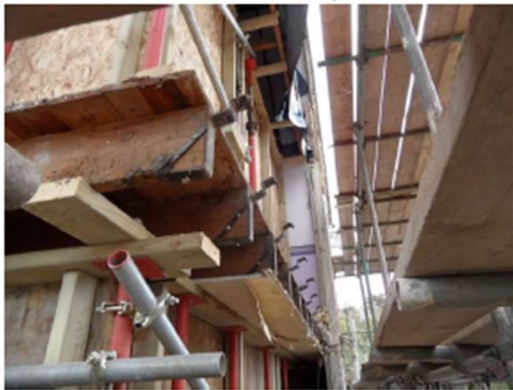
P11 – Demolition

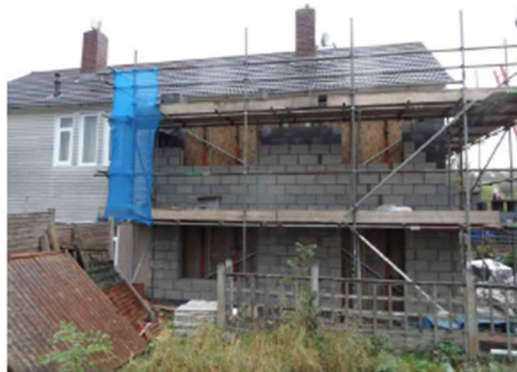
P12 – External Walls
